## 1. Identification / Recognition

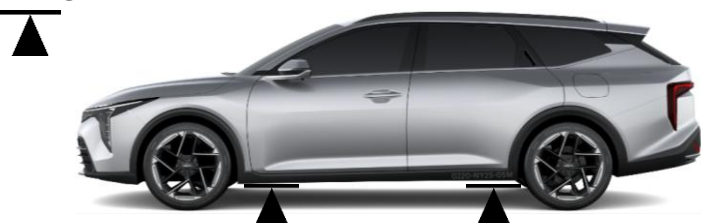
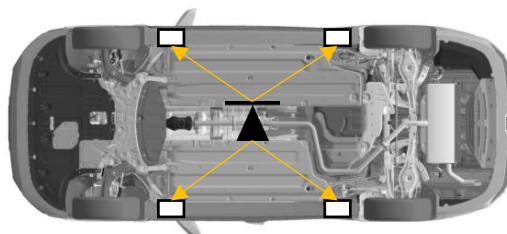
**Lifting points underneath the vehicle:**

To stabilise the vehicle, place wooden blocks or similar objects to at four points directly under the front and rear pillars.

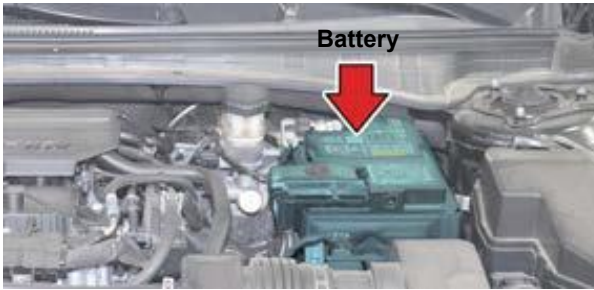
Disabling the 12 V battery:

Battery in the engine area

**Disconnect the 12V battery (shown on page 3) under the bonnet**

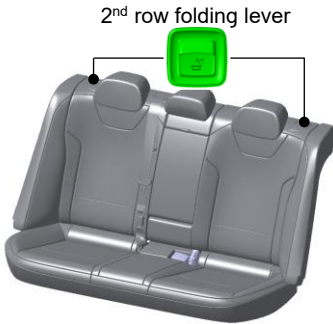
Seat adjustment:

MANUAL

POWER

2nd row folding lever

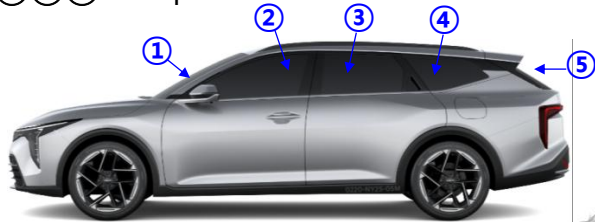
Glass:

- ① Laminated
- ② : Tempered (OPT: laminated)
- ③④⑤: Tempered

Vehicle body → Hardened steel

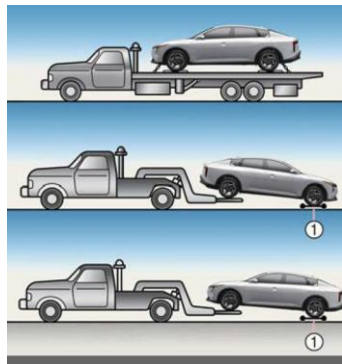
OK

Note: The use of wheel dollies (1) or a flatbed is recommended. Use a wheel lift or flatbed equipment.

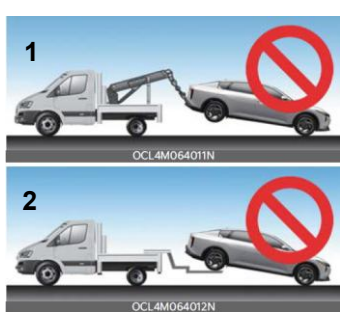
Not OK

Note: Do not tow using sling-type equipment (1). Do not tow the vehicle with the front wheels on the ground as this may cause damage to the vehicle (2).

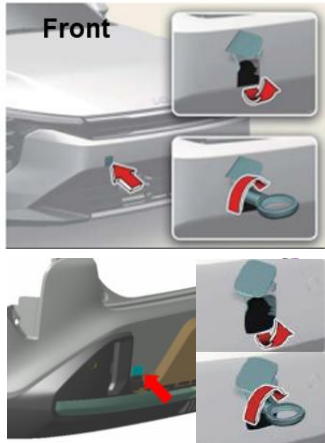
Towing hook

The towing hook is located in the tool case in the boot.
